Wilma's aftermath: Roofers struggle on

A Porch for All Hours

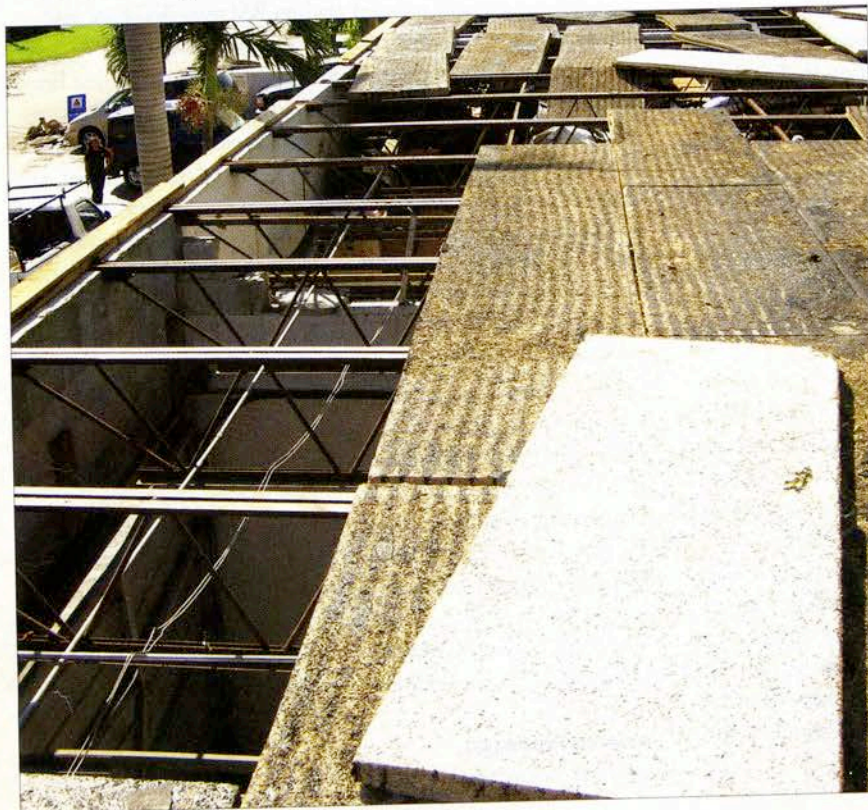
Many commercial buildings were damaged when roofs peeled back, revealing metal decking, such as this roof in Pompano Beach, FL. (Photo courtesy of Billy Cone, president, Rooftech Roofing & Sheet Metal, Ft. Lauderdale, FL.)

"A lot of hip and ridge tile was lost," according to Munnell. "Older shingles did not fair too well, but the newer shingles that meet the codes that went into effect after (the South Florida Building Code) and now the Florida Building Code fared much better."

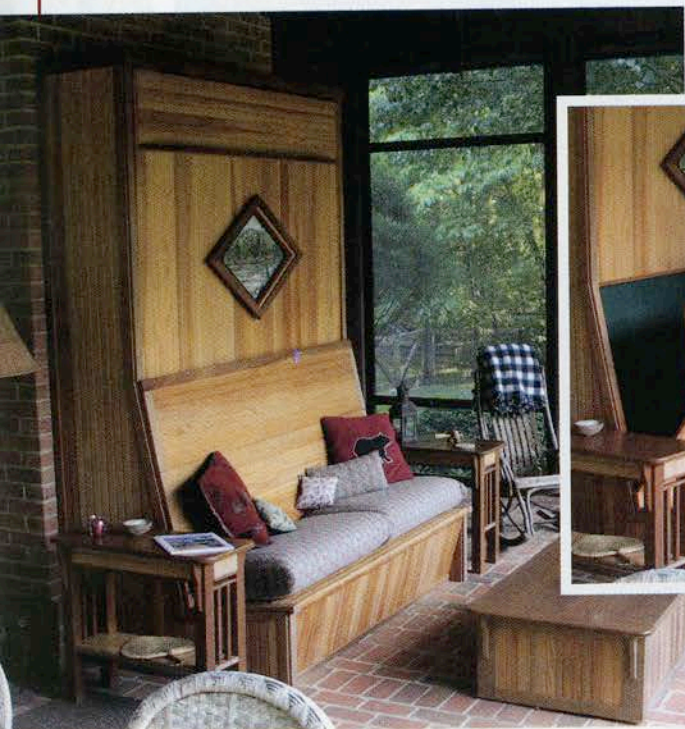
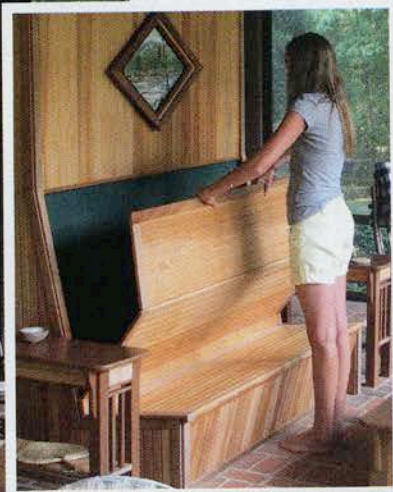
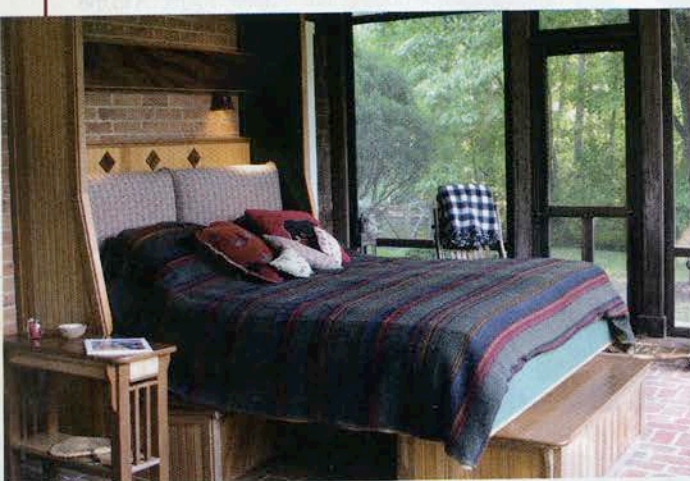
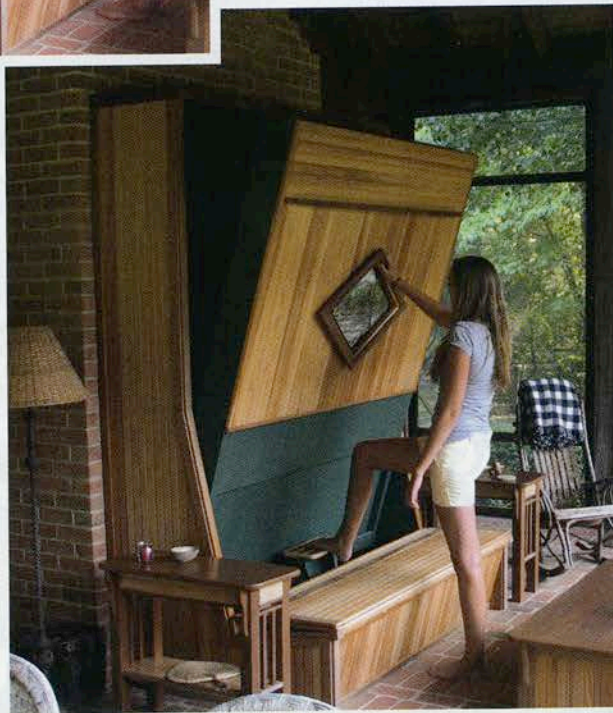
The challenge was to build cabinetry to make an ordinary Murphy bed fit in with the Adirondack-style decor of the customer's screen-porch: The successful result is shown in the photos below. By day, the bed is concealed

behind a bench seat, which is flanked by matching end tables. A cedar-lined chest serves as a coffee table (top left).

When the sun goes down, the porch can easily be transformed into a bedroom. The bench's back folds onto the seat (top right); the picture frame doubles as a handle (bottom right) to pull the bed down to rest upon the blanket chest (bottom left). Uplighting for mood and downlights for reading are mounted in the headboard, which also hides a stereo.

The four-piece unit was designed by master carpenters Mike Hover and Eric Smith in collaboration with Mary Gunion (the homeowner) and Ron Cascio (the owner of the design/build company Chestnut Creek, in Berlin, Md.). Hover and Smith crafted the furniture from beaded yellow pine, Philippine mahogany, and eastern red cedar. — Laurie Elden
